Road Construction In Environmentally Significant Area

Construction of Doctor Kay Drive

Ainley & Associates Limited

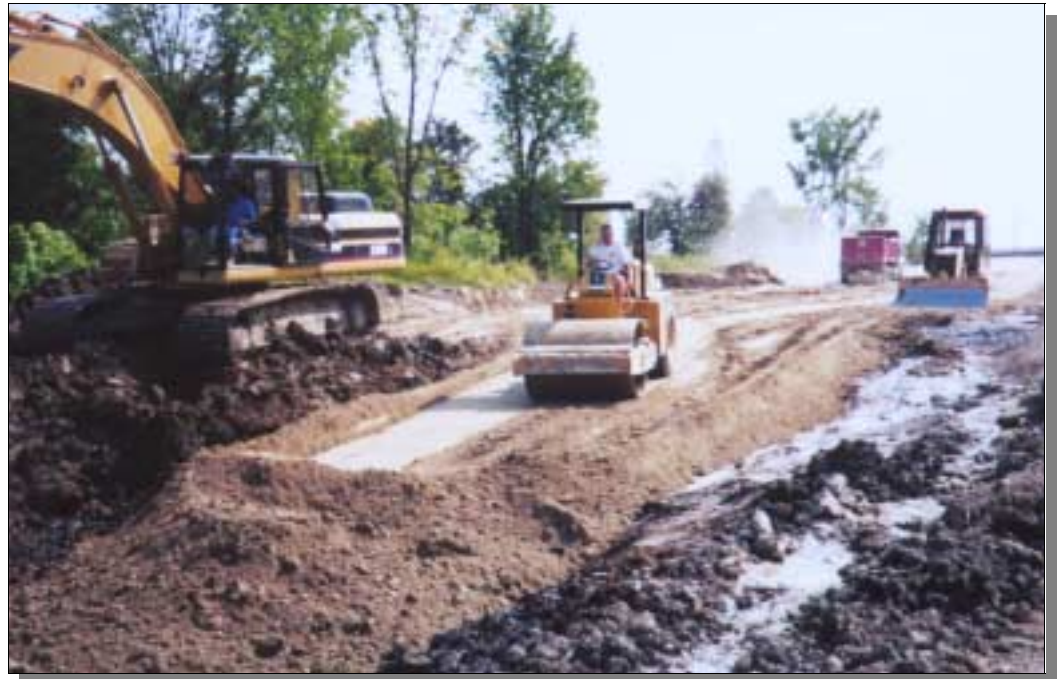
Challenging site conditions for construction of Doctor Kay Drive

Construction of Doctor Kay Drive took place along an existing abandoned rail right-of-way that bisects the Dufferin Marsh. The new road was needed to provide direct access into the core of Schomberg from Highway 27, and to improve safety and ease of access to external commercial services on Highway 27. In addition, the road would link the two major commercial cores of the Town, relieve traffic congestion, and improve traffic circulation from new housing developments. A traffic impact study prepared for the Region of York recommended that at least one lane on Highway 27 remain open at all times through the traffic staging plan.

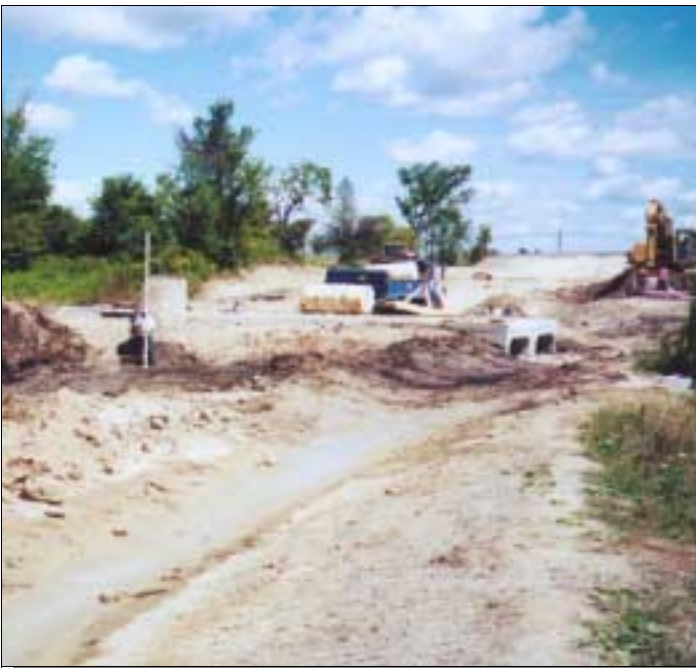
Precast concrete culvert with transition slab

The submerged twin-cell (0.9 m high x 1.8 m wide x 17.5

m long) precast reinforced concrete box culvert was designed with a transition slab.

The road grade had to be lowered to accommodate complex stormwater management plans for the marsh and downtown core. The culvert had to maintain constant flow from both sides of the marsh, and at the same time provide relief to the core area in the event of a flood. The road and culvert were designed to allow floodwaters to flow in a sheet over the road to prevent a backup and flooding in the town. Because of this, the backfill cover over the culvert was minimal, requiring a slab to strengthen the installation. The contractor was able to dewater the site for the box units, and set them on a granular base. This was not possible for alternative culvert designs and material due to special footing requirements and minimal backfill over the culvert.

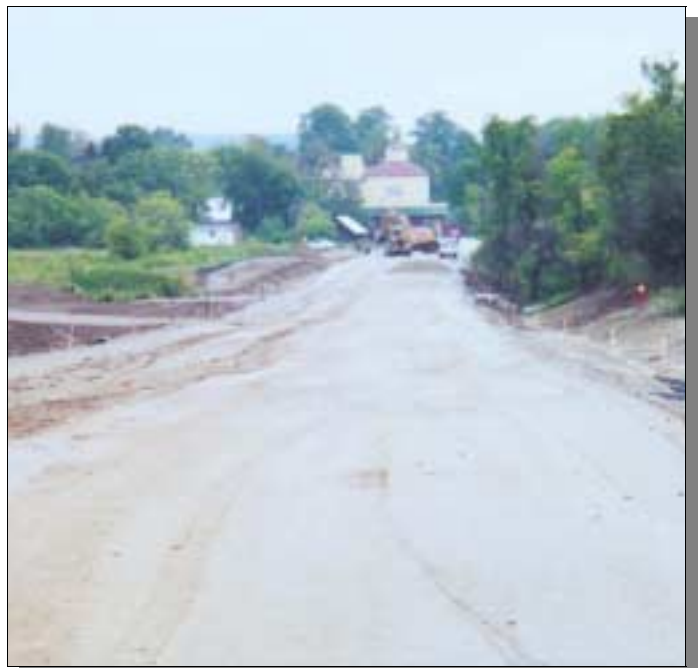
Completion of Doctor Kay Drive road base
